CAI Home Inspection

Property Inspection Report

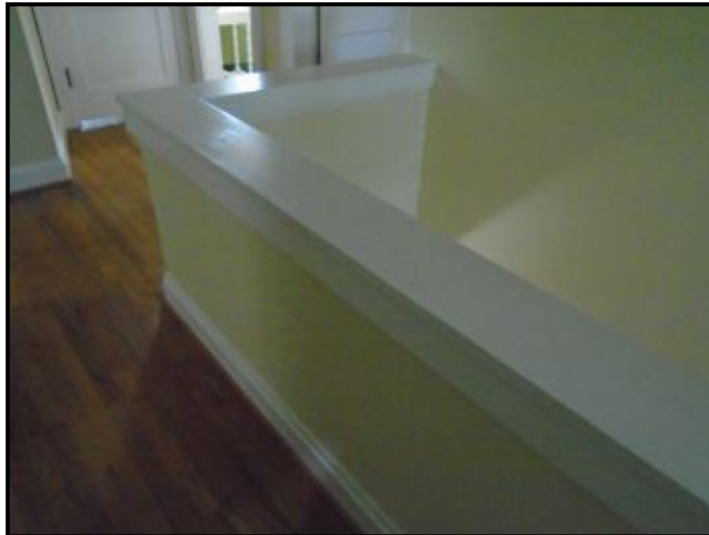
Recommend increasing height of guardrail at top of stairs at 2nd floor to a minimum of 36 inches (2).

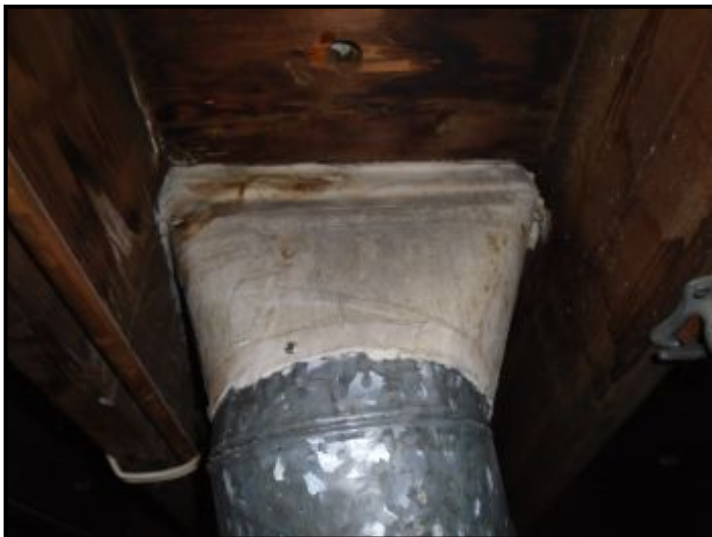
Possible asbestos materials observed at the HVAC ductwork (2). Laboratory testing must be performed to determine if asbestos is present in the ductwork insulation (2).

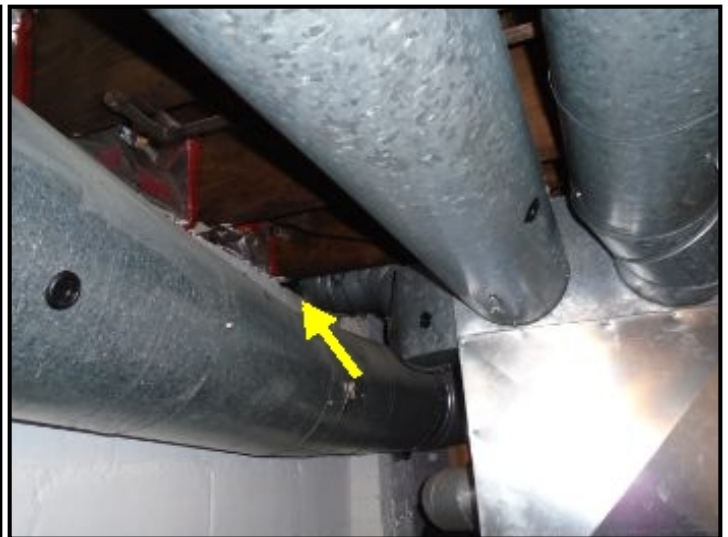
Location of next photo.

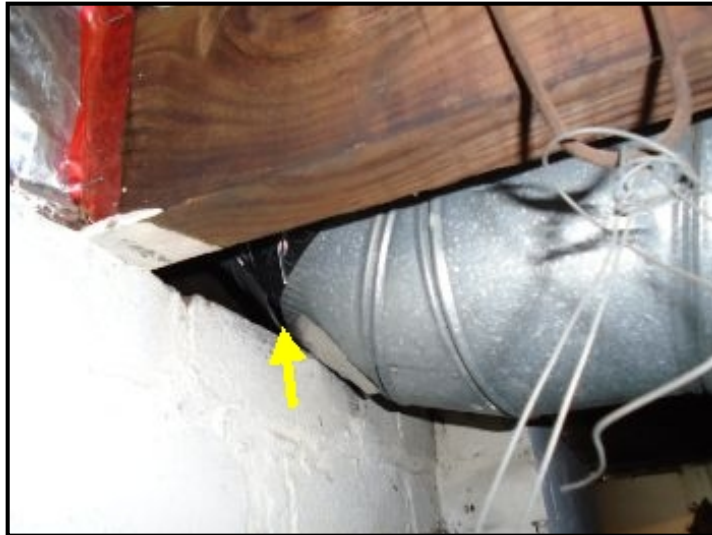
Recommend sealing all gaps, cracks and holes in the HVAC duct system for increased efficiency and lower energy bills (1).

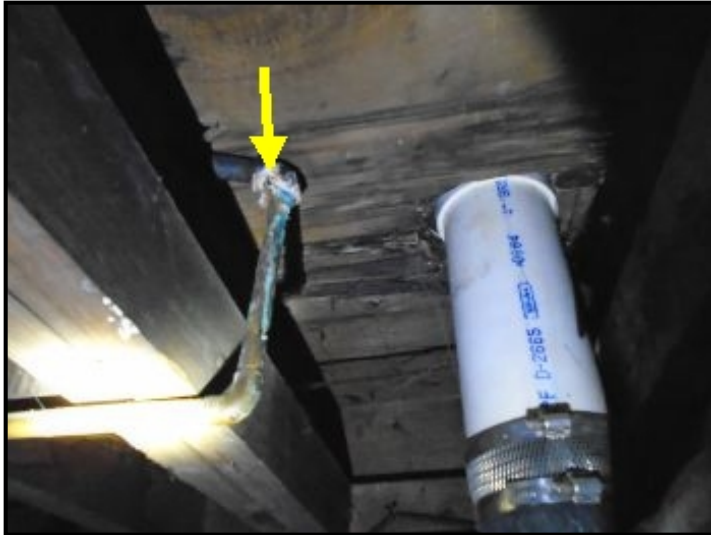
Corrosion observed on copper water line in basement should be cleaned and monitored to ensure corrosion is not continuing (1).

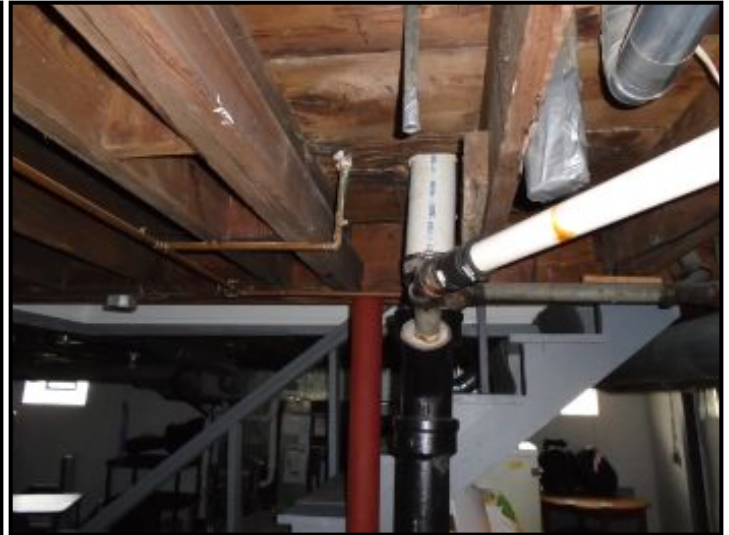
Location of previous photo.

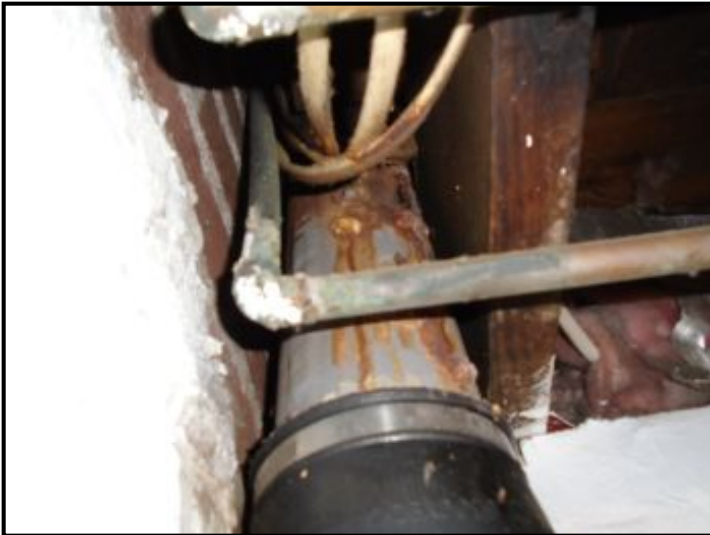
Corrosion / stains observed from previous leaks at the main drain line observed in basement (1). No current leaks observed; however, monitor for leaks and repairs may be required to corroded metal drain (2).

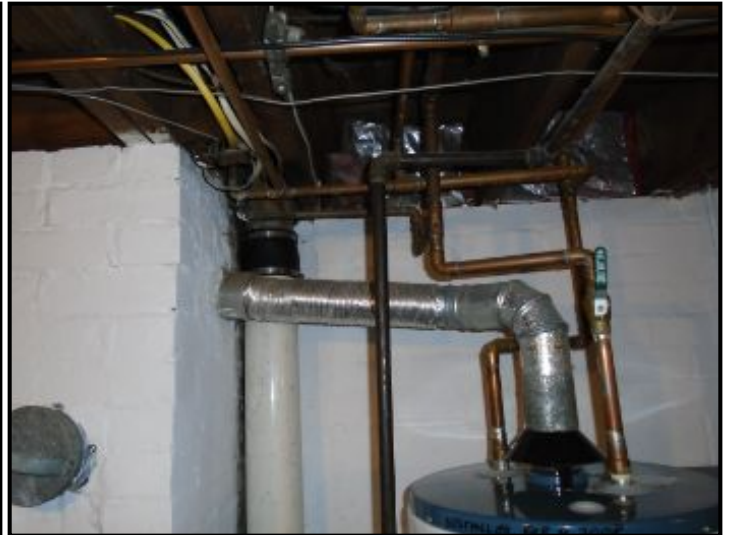
Location of previous photo.

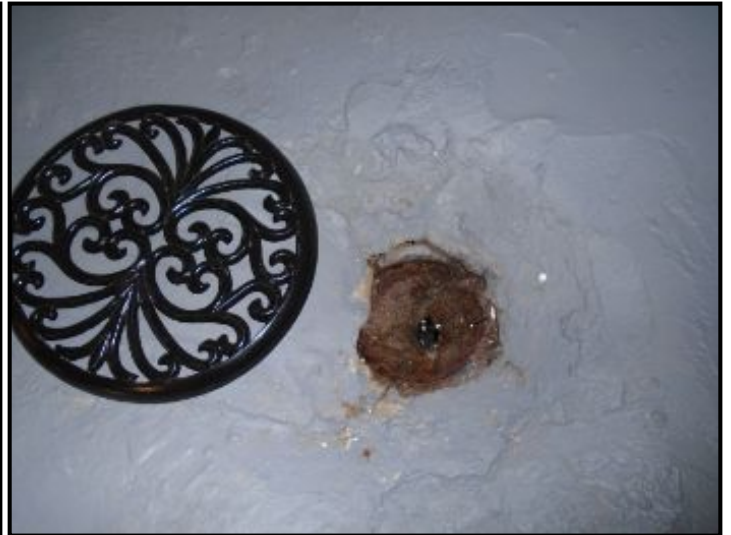
Basement floor drain has corroded significantly (2).

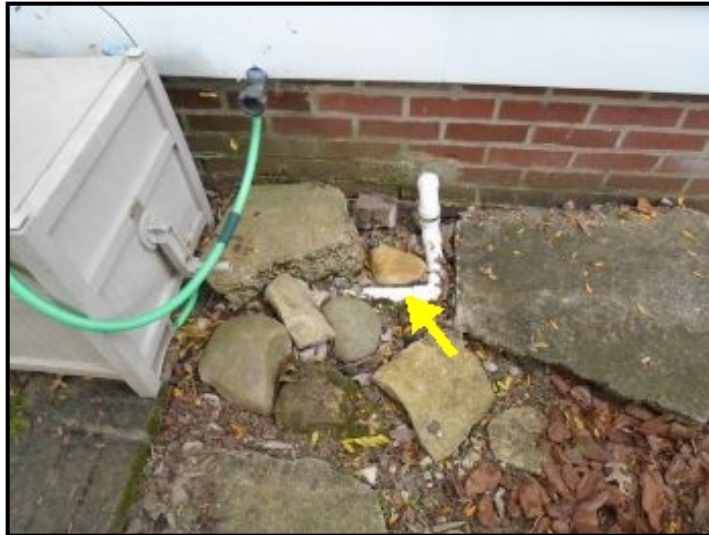
The sump pump discharge line was loose at the fittings on the exterior (2). Ensure line is connected properly at the joints and is water tight (2).

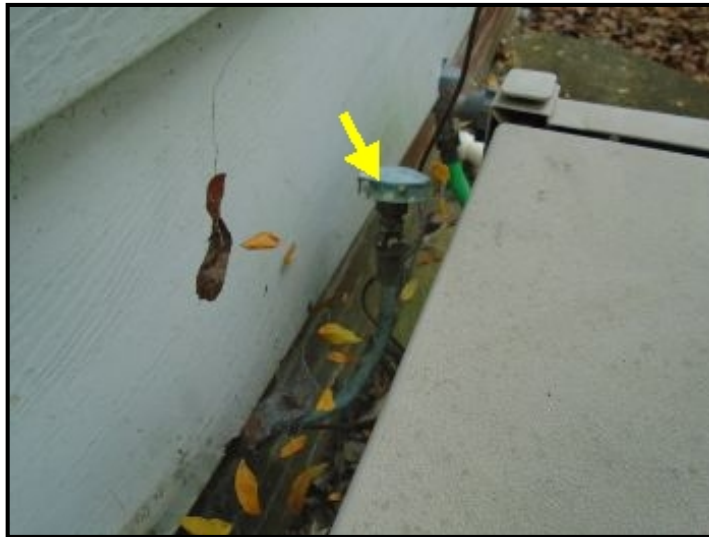
Copper gas line exits house and terminates near sump discharge is not being used and should be cut off inside and capped to prevent possible damage and resulting leak (2).

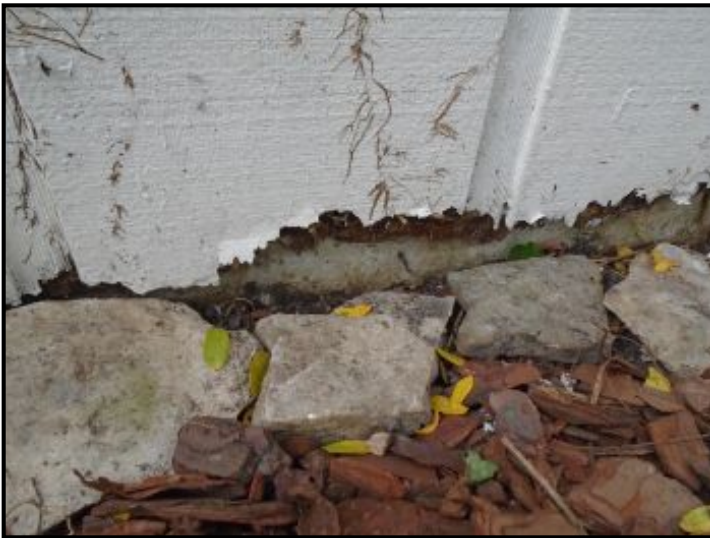
Garage wood siding and trim was in contact with the soil and rotted / termite damaged in several locations (2).

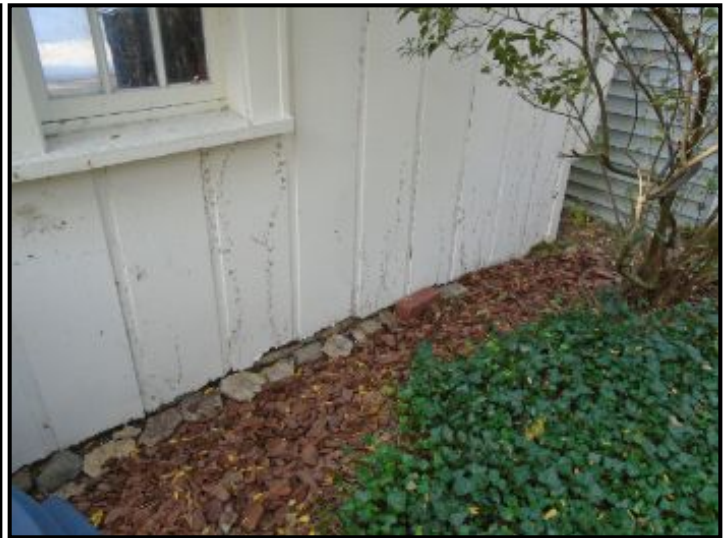
Location of previous photo.

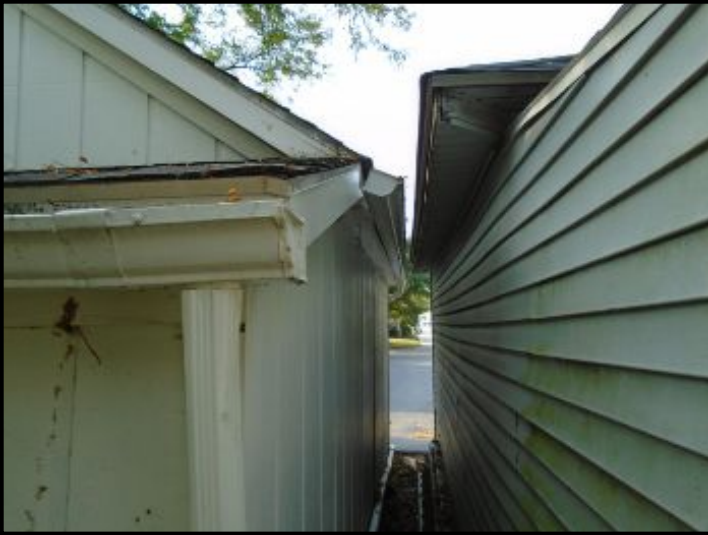
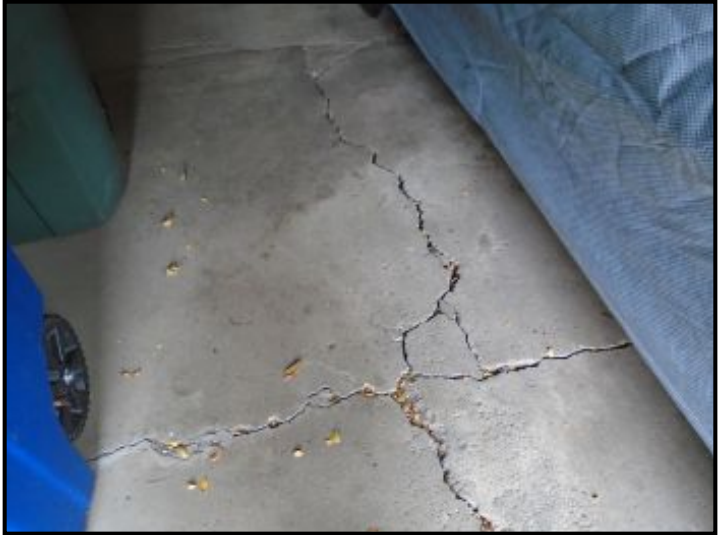
Garage gutters clogged (2). Gutters loose and need refastened (2). Improperly functioning gutters and downspouts has allowed water accumulation adjacent to the structure which has caused significant cracking of the concrete slab (2). The adjacent garage owned by the neighbor does not have a gutter and allows water to run off adjacent to the garage contributing to wood rot and settlement of the structure (2).

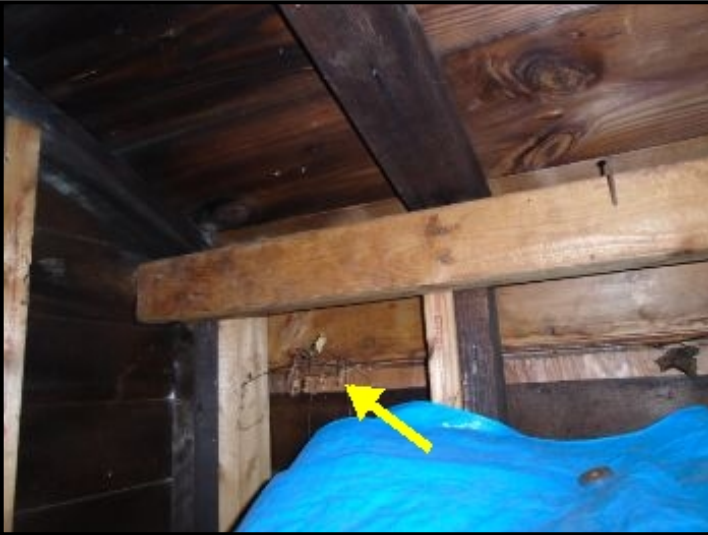
Vegetation observed growing through structure and should be trimmed back (2).

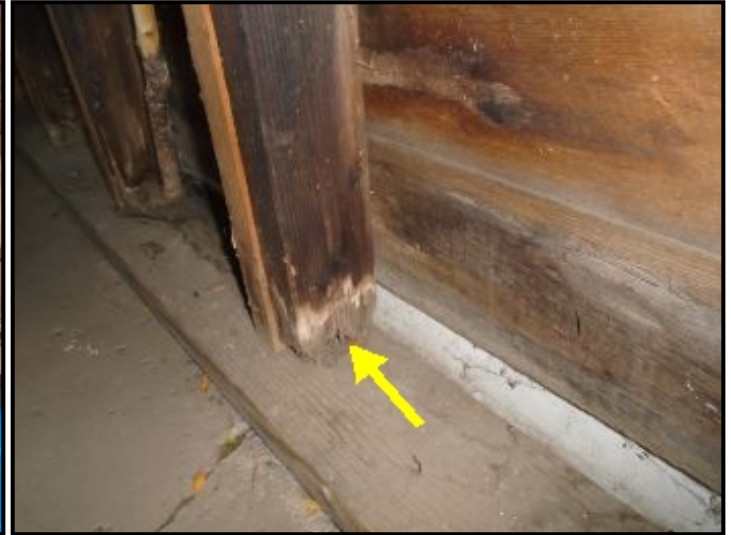
Termite damaged 2x4 studs have been previously repaired / splinted with additional 2x4 studs (1). Monitor for future termite activity (1).

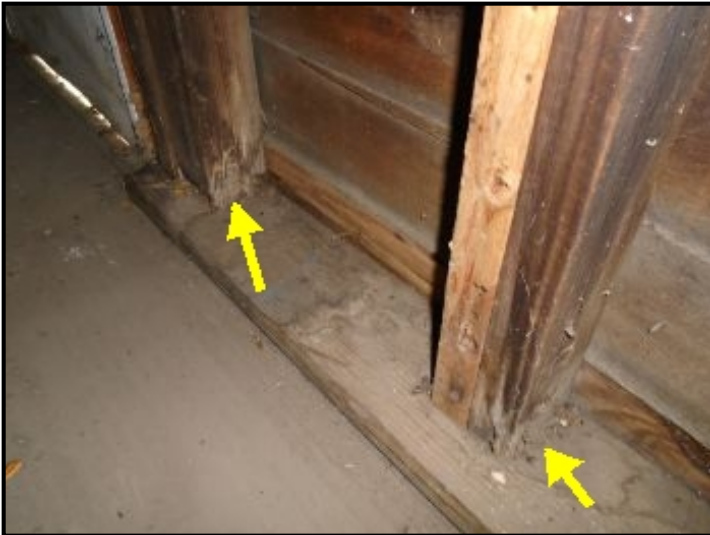
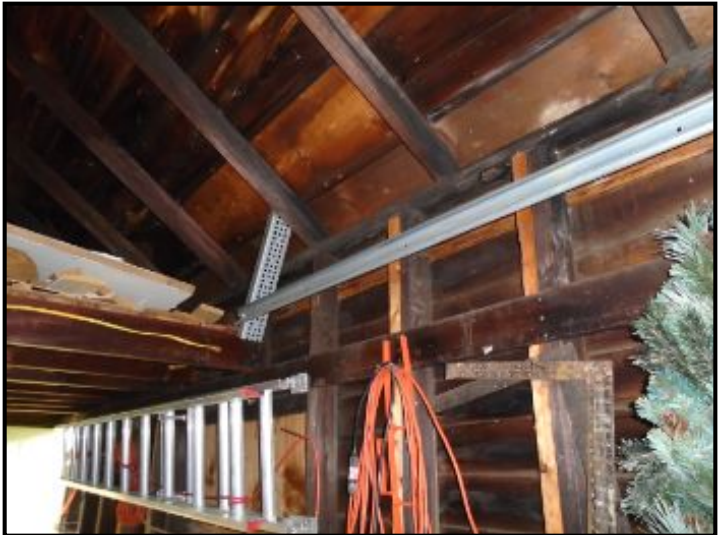
Termite damaged 2x4 studs have been previously repaired / splinted with additional 2x4 studs (1). Monitor for future termite activity (1).

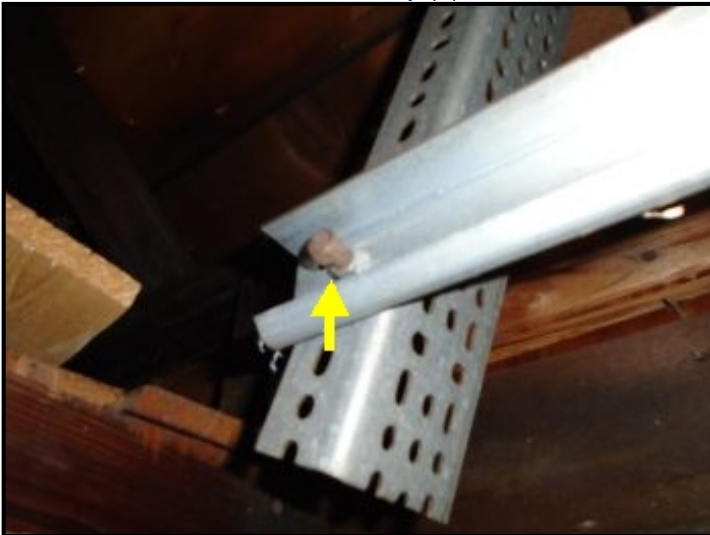
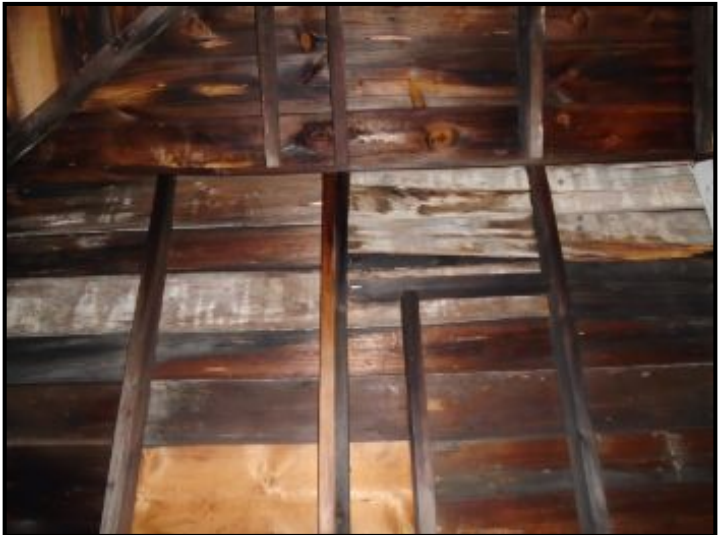
Bolt needs tightened at garage overhead door track (2).

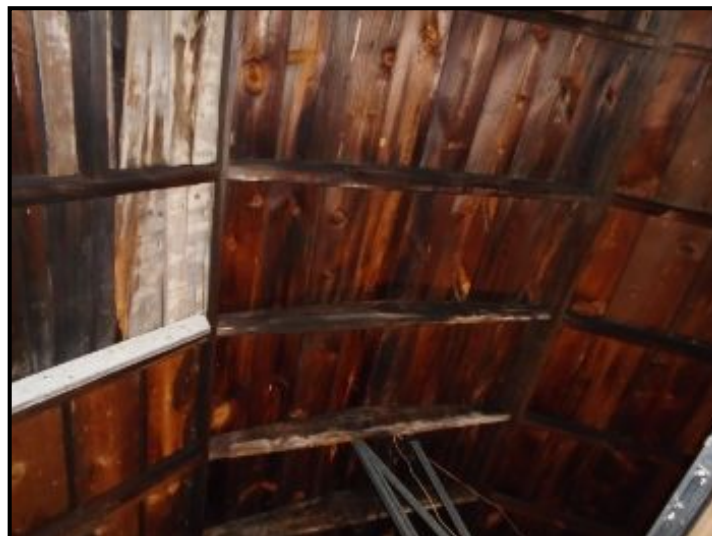
Water stains / water damage observed on roof framing indicating previous roof leaks (1). Repair any damaged boards that are rotted or weakened (2).

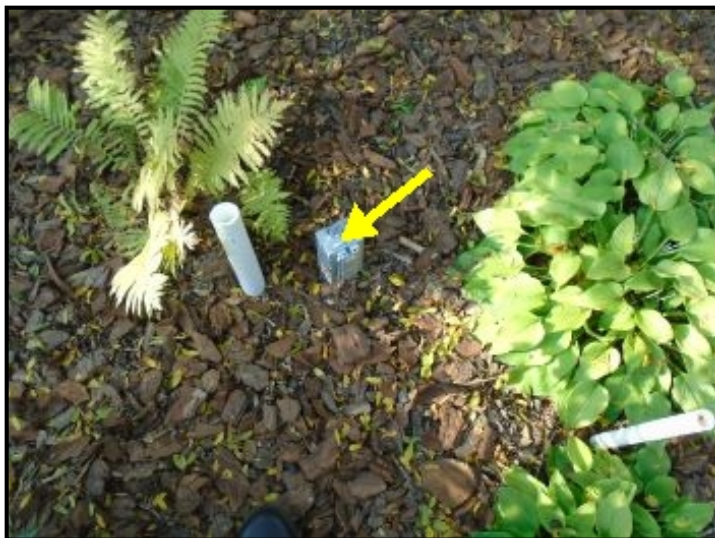
Exterior yard GFCI outlet test/reset buttons were not functioning (2).

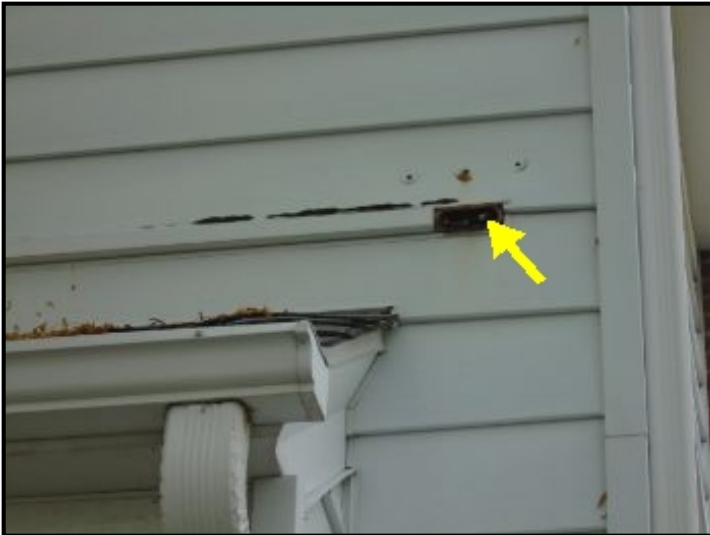
Remove exposed wiring and junction box at rear of house and repair siding as needed (2).

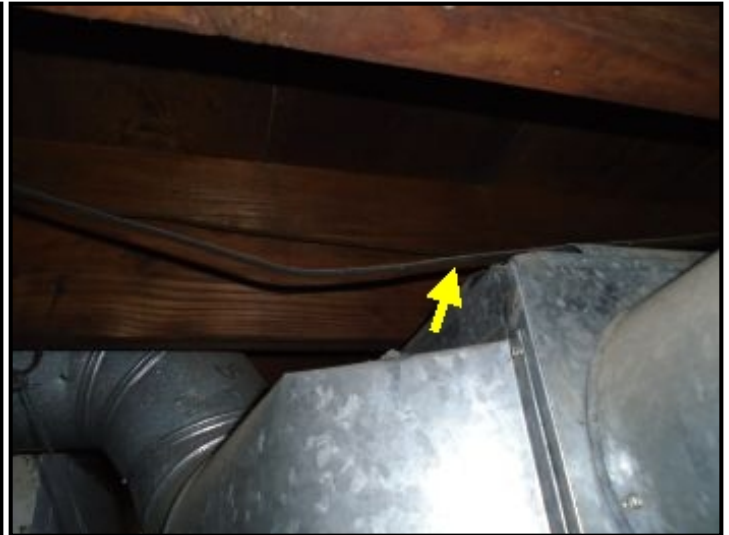
Knob and tube conductor was sagging and resting on the HVAC duct work which could energize the duct system if any insulation is damaged and exposing the copper conductor (2).

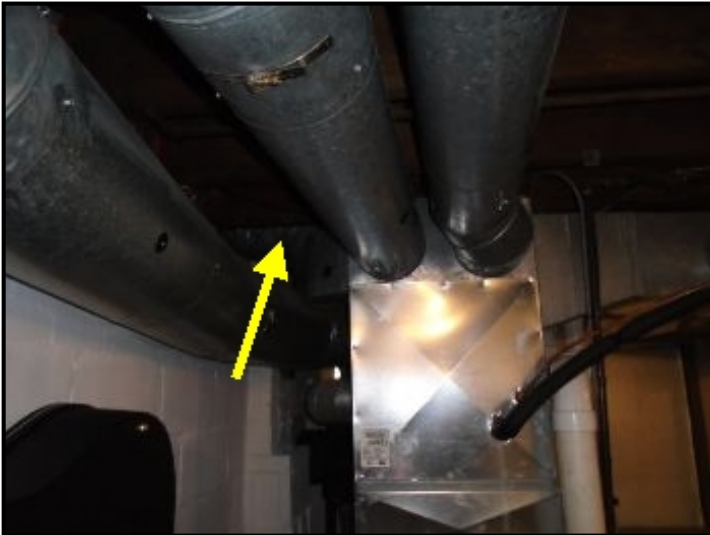
Location of previous photo.

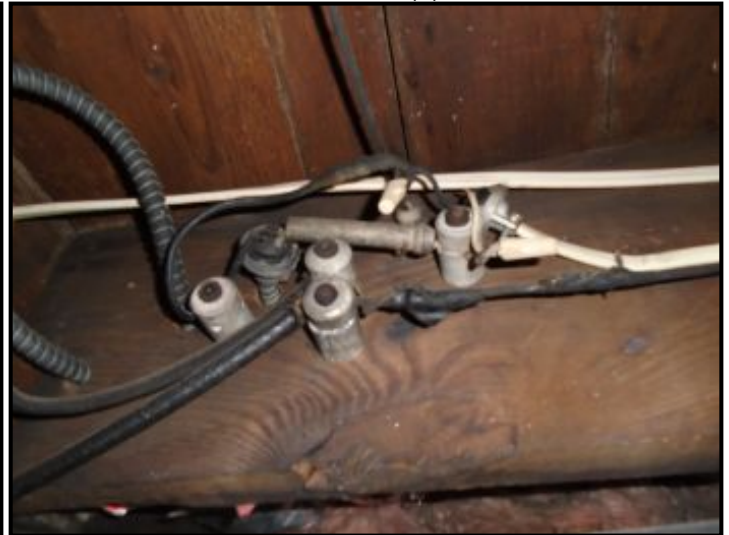
This property has "knob and tube" wiring which was commonly installed prior to 1950. It is ungrounded and considered unsafe by today's standards (2). Over time, the wire's insulation becomes brittle and falls apart, resulting in exposed conductors and a risk of shock and/or fire (2). A qualified electrician should replace the wiring as necessary (2). Knob and tube wiring was observed in the basement, attic, and through the walls as seen at several outlets at the first floor and upstairs bedrooms (2). Recommend replacement of any other ungrounded cables including metallic sheathed cables as required (2). Recommend GFCI outlets in Kitchens, Bathrooms, Garage, Laundry Area, Exterior, and other required areas (2). Upgrade outdated lights switches and outlets (2).

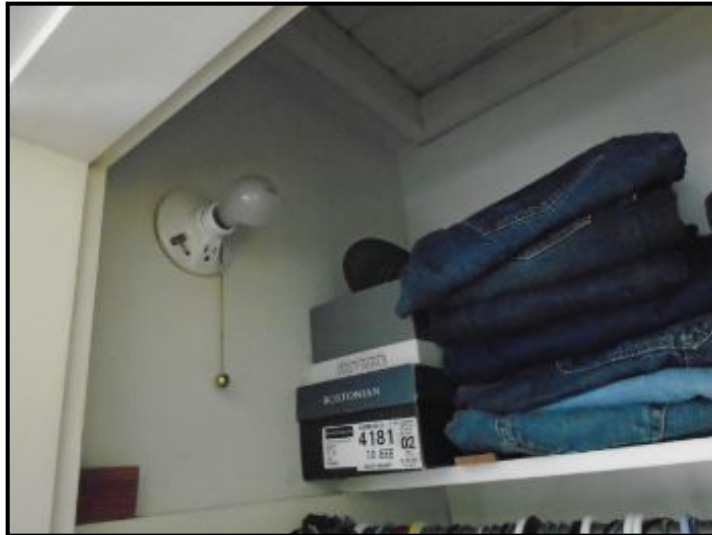
Incandescent light fixture installed in closet does not have the required 12 inches of clear space between the fixture and storage areas (2). Replace fixtures in all closets (2).

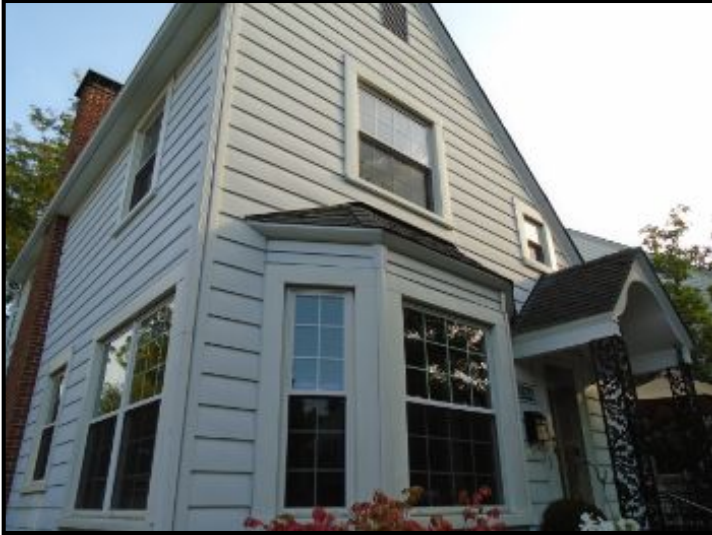
Location of next photo.

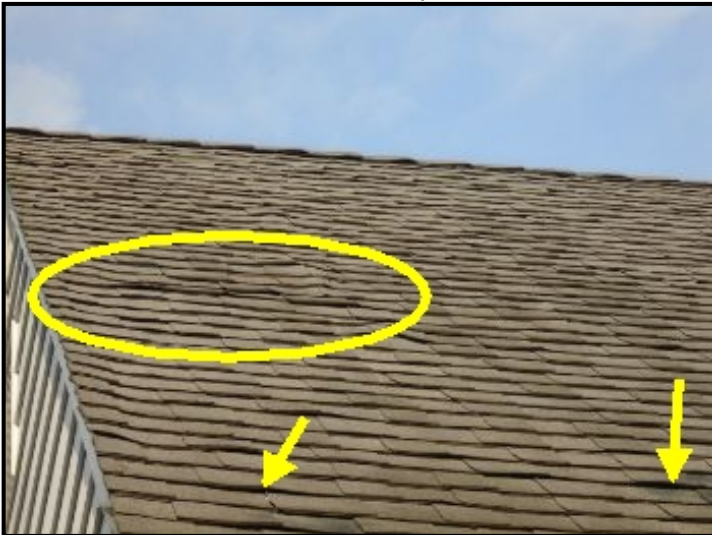
Overall, roof is in marginal condition with several shingles showing signs of significant deterioration and surface wear (1). Significant curling and cupping of the shingles were observed in several locations (1).

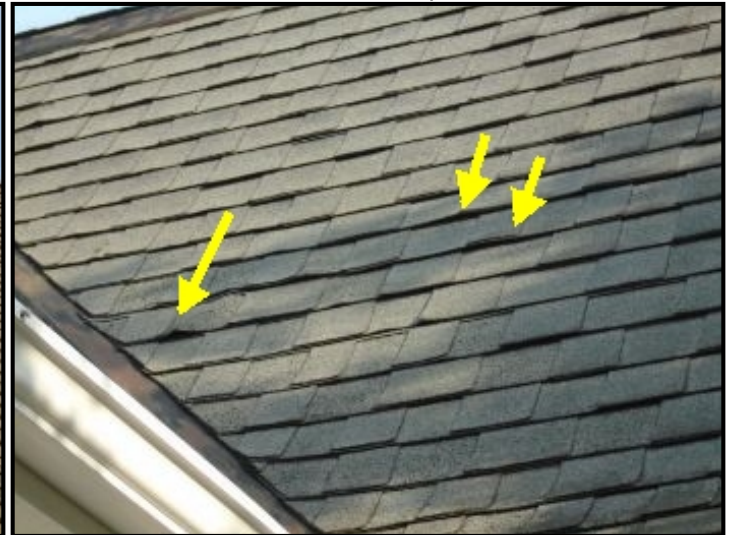
Overall, roof is in marginal condition with several shingles showing signs of significant deterioration and surface wear (1). Significant curling and cupping of the shingles were observed in several locations (1).

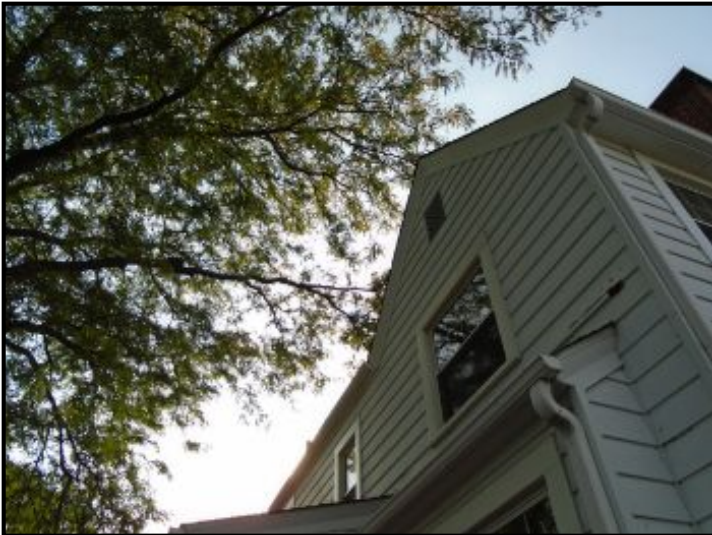
Trim back tree branches that overhang the roof to prevent damage / wear on the roof (2).

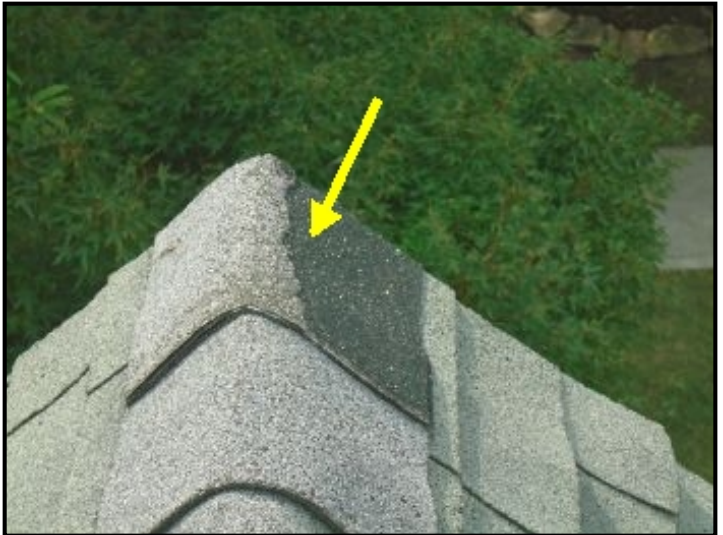
Overall, roof is in marginal condition with several shingles showing signs of significant deterioration and surface wear (1). Significant curling and cupping of the shingles were observed in several locations (1).

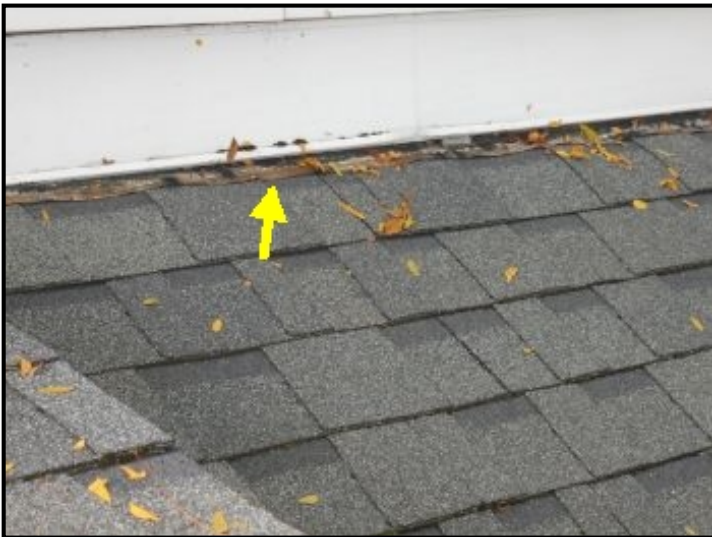
Flashing beginning to rust / deteriorate in several locations (2).

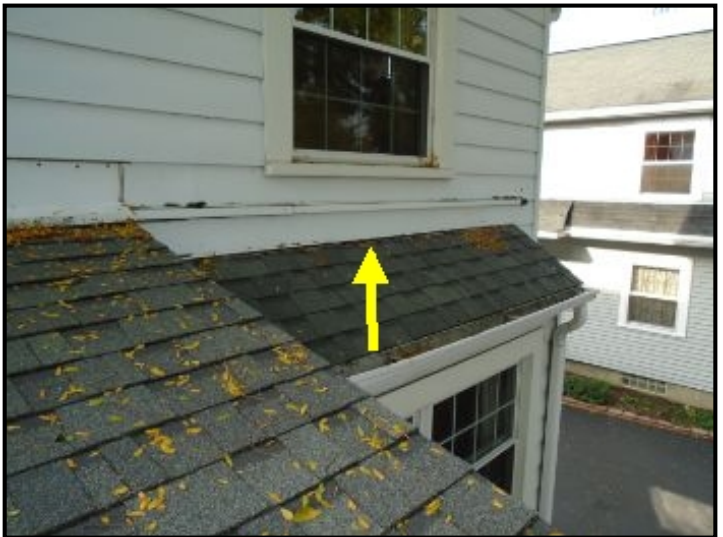
Location of previous photo.

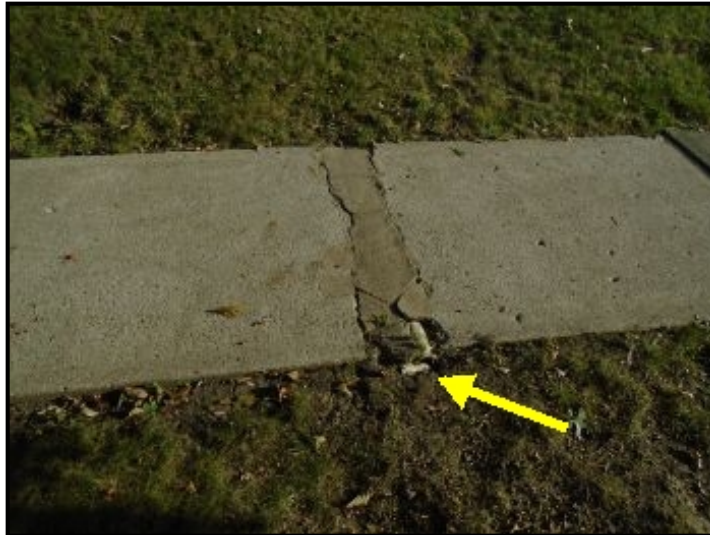
Downspouts discharge to a location just beyond the sidewalk which will allow water accumulation and ice formation in the winter which is a trip hazard (2). The sidewalk has been damaged where the outlet pipe was installed (2). The downspout outlet appears clogged with soil which may allow water to back up and discharge at the downspout connection near the house (2).

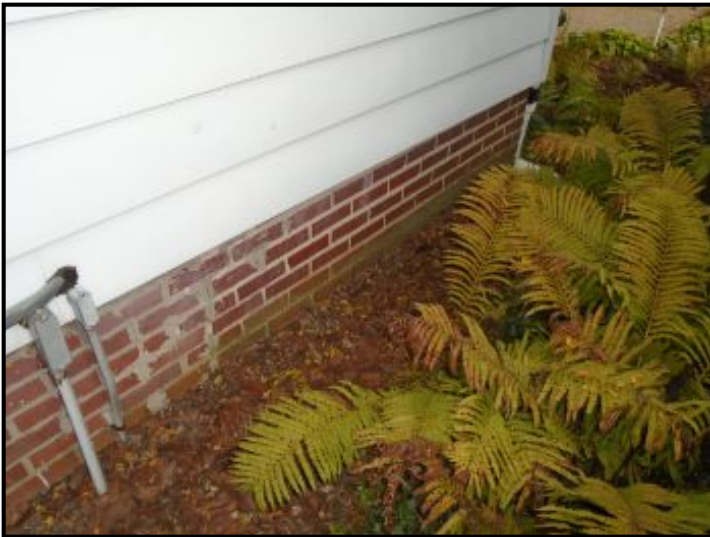
Location of next photo.

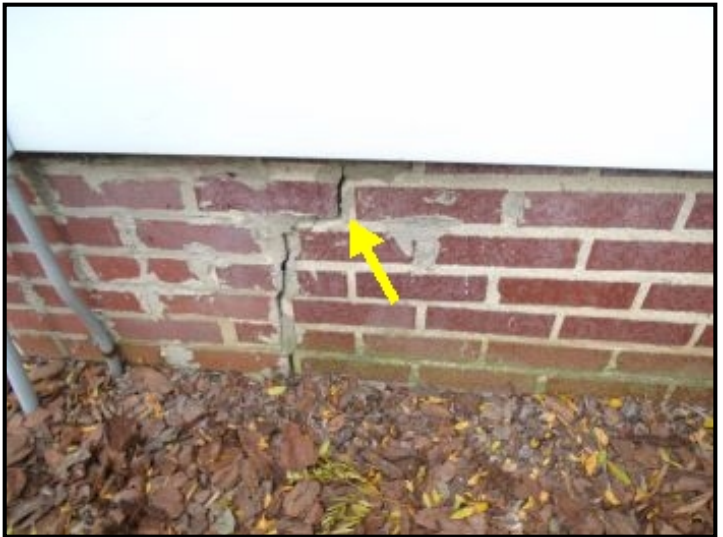
Cracks observed along brick veneer should be tuck-pointed to prevent further freeze thaw damage (2).

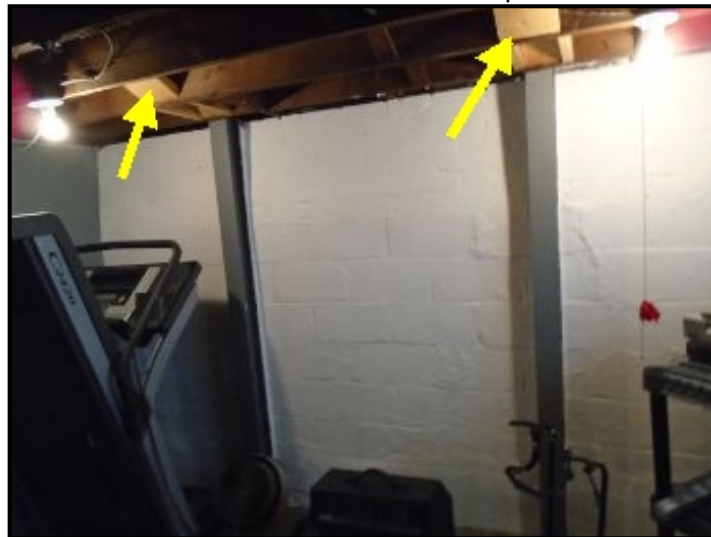
Rear and half of the front foundation walls had previously bowed and cracked and the walls were reinforced with vertical steel beams (1). Ensure all exterior drainage items such as downspouts and gutters are working properly and no low spots occur at the ground adjacent to the structure which could allow water accumulation and further cracking/bowing of the foundation wall or water intrusion (1). Steel beam connection to floor framing appeared marginal (2). Request structural repair drawings / permits of the work that was performed to ensure the repair was designed by a structural engineer (2).

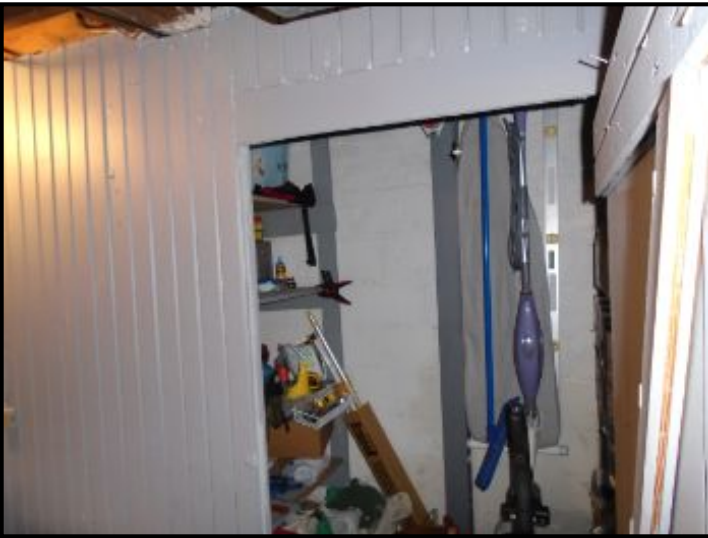
Location of next photo.

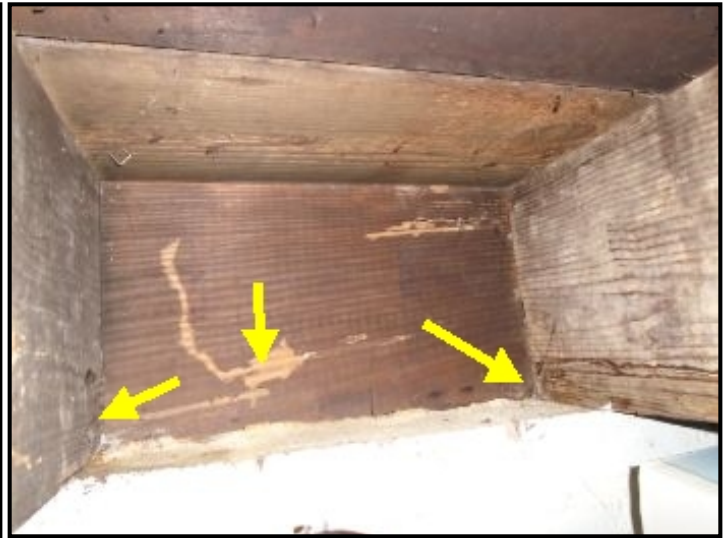
Termite damage to the wood floor joists and framing on top of the front foundation wall was observed in the basement; however, no current signs of active infestation was observed (1).

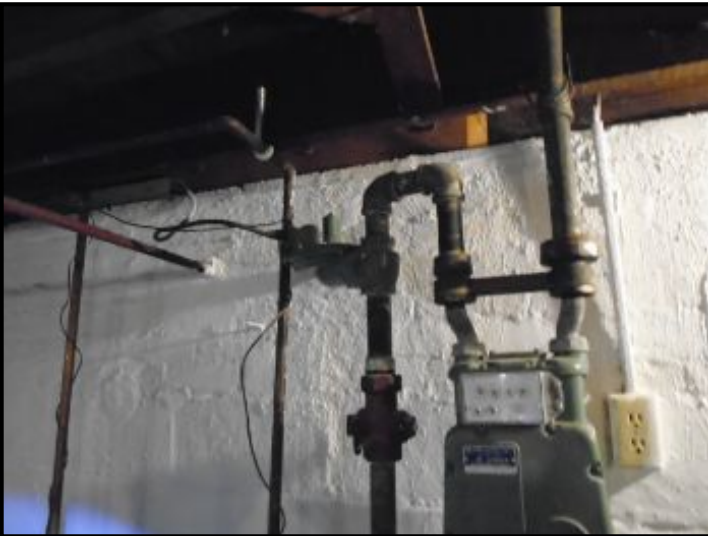
Location of next photo.

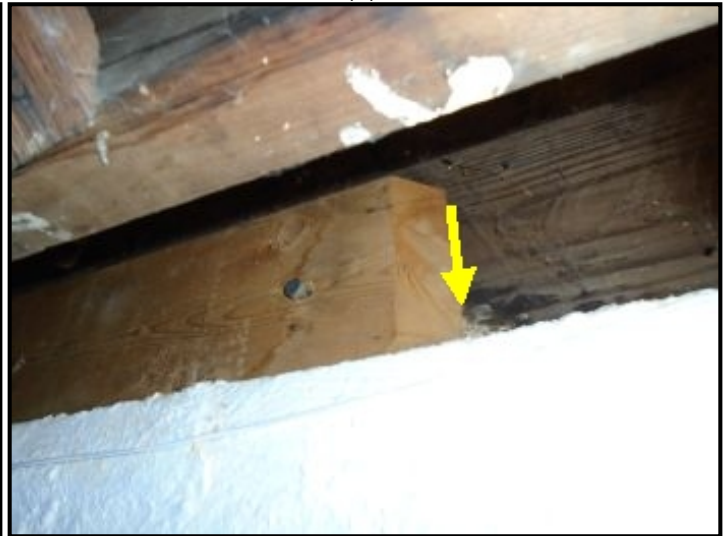
Repair to joist on top of foundation wall observed near gas meter may have been due to previous termite damage; however, damaged wood was covered by the new wood splice (1). No current signs of active infestation were observed (1).

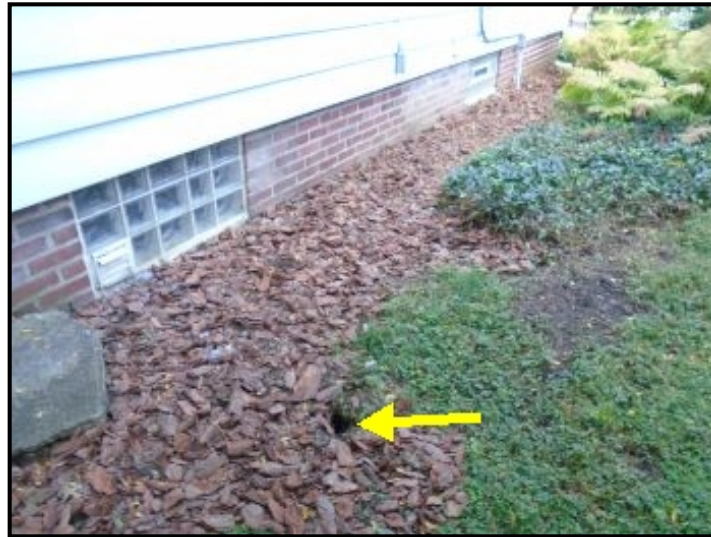
Holes observed adjacent to the house in several locations that have been dug out by a burrowing animal (2).

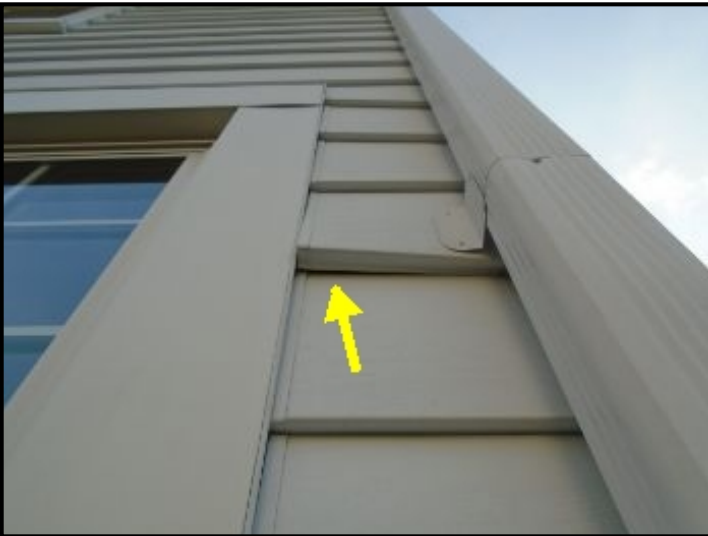
Loose siding needs refastened at front right side (2).

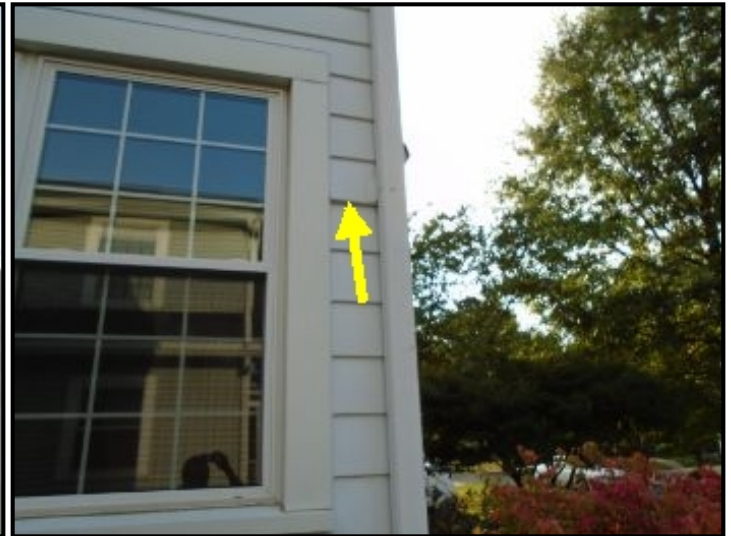
Location of previous photo.

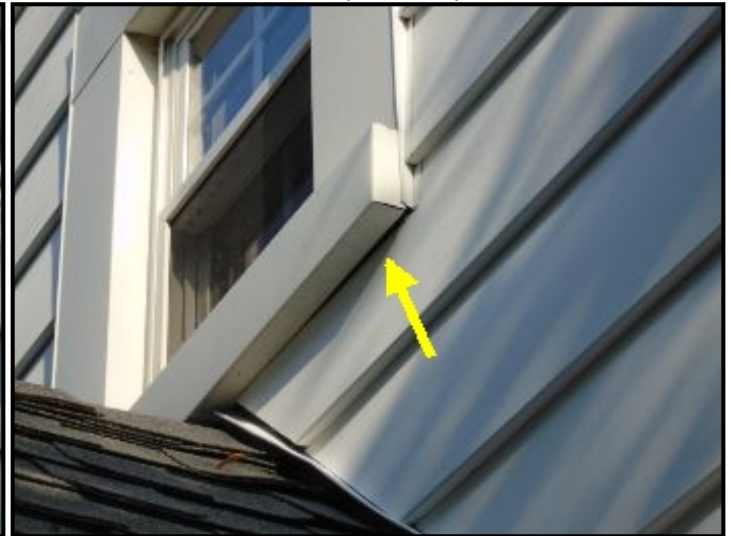
Repair all gaps in siding to prevent moisture / pest entry (2).

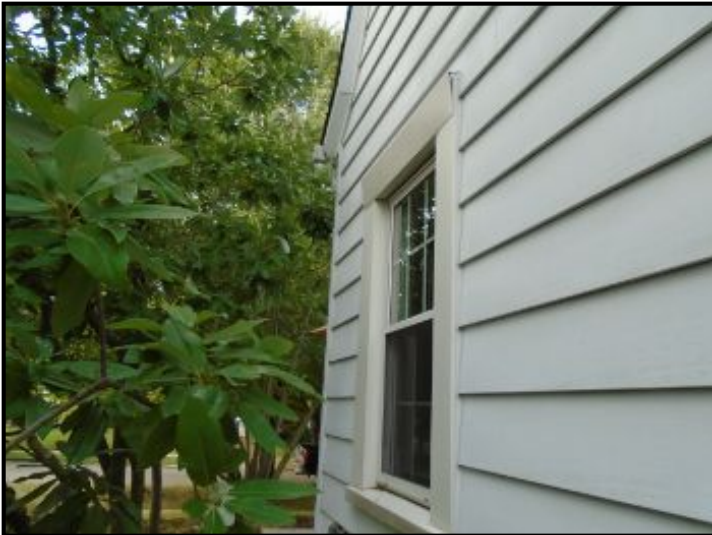
Location of next photo.

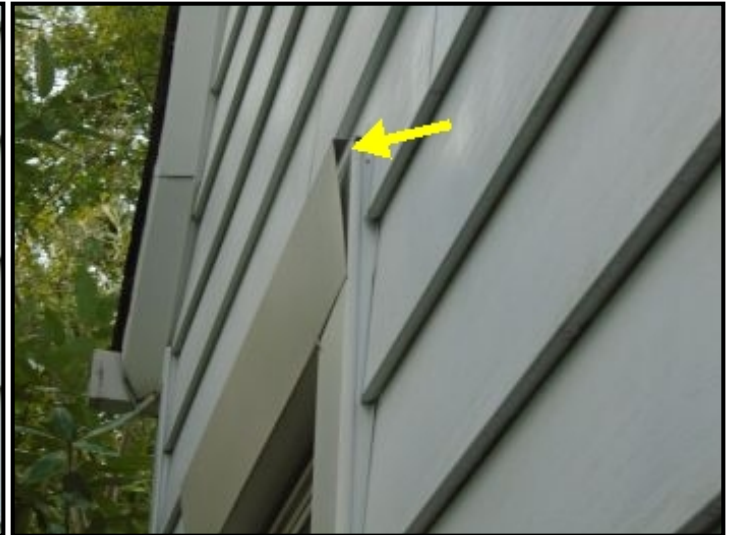
Loose siding needs refastened at front right side (2).

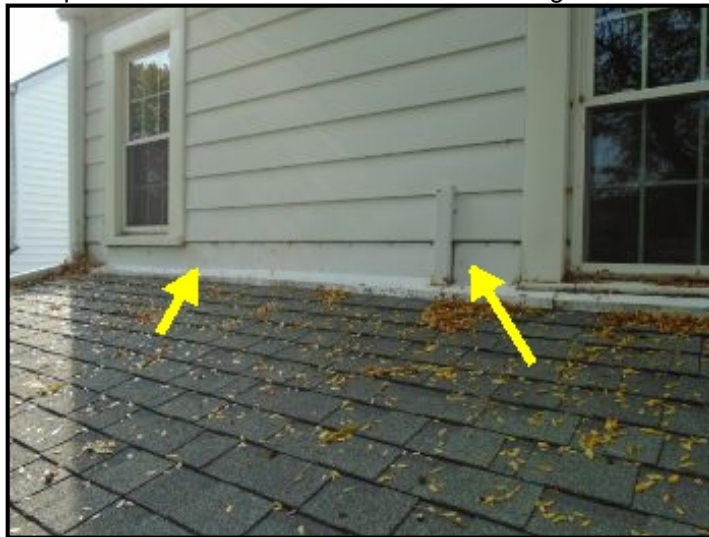
Marginal installation of rear siding along bottom course at the roof edge (2). Fasteners were nailed through the siding which may allow water intrusion (2). Gaps exist along the top edge of the siding that does not appear adequately sealed (2).

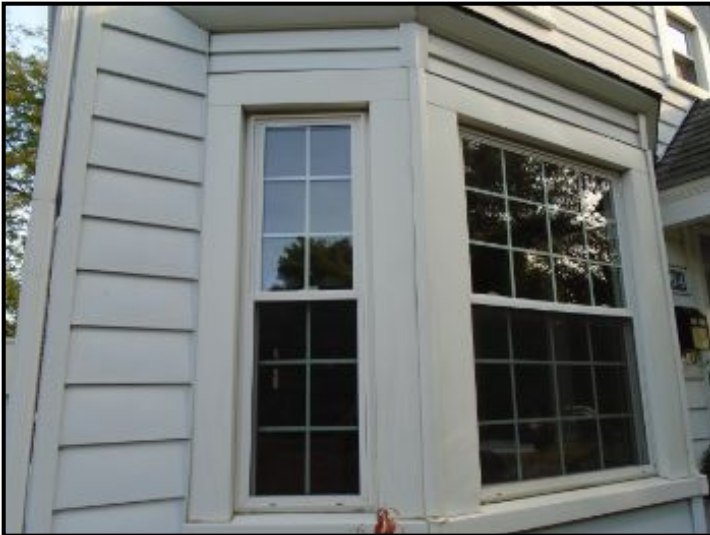
Location of next photo.

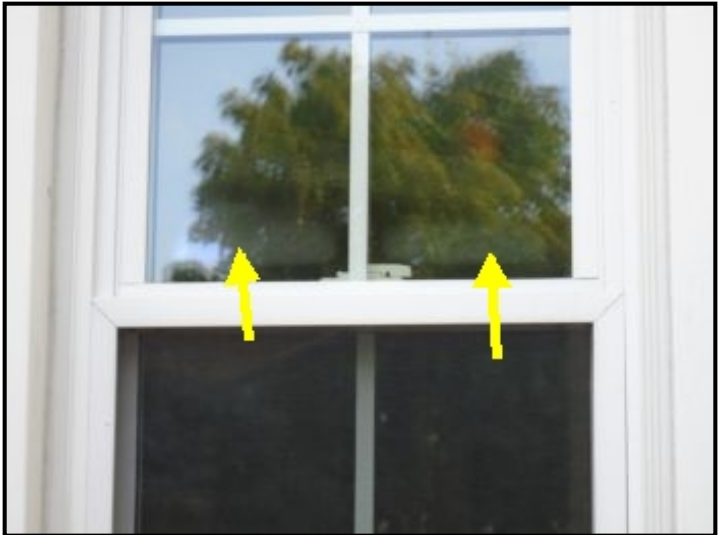
Fog/condensation observed at the front left and front right windows which is an indication of a failed seal (2).

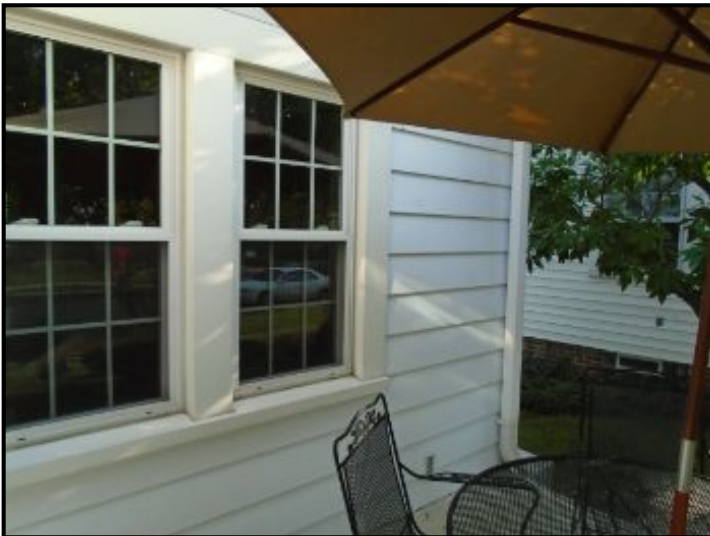
Location of next photo.

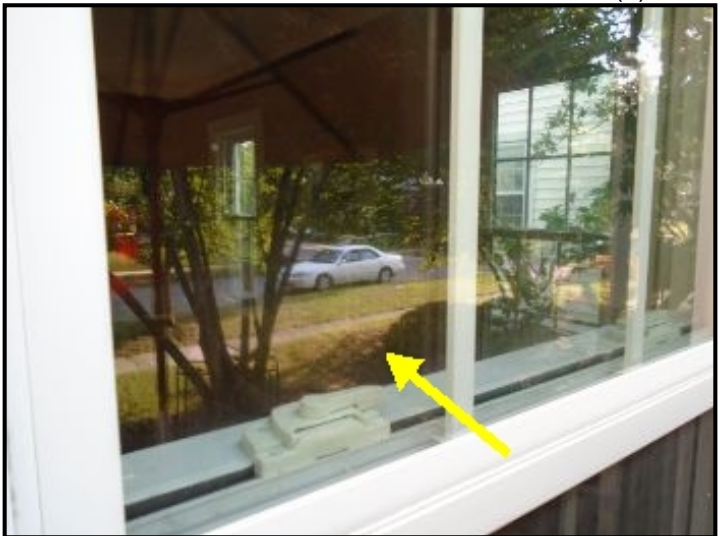
Fog/condensation observed at the front left and front right windows which is an indication of a failed seal (2).

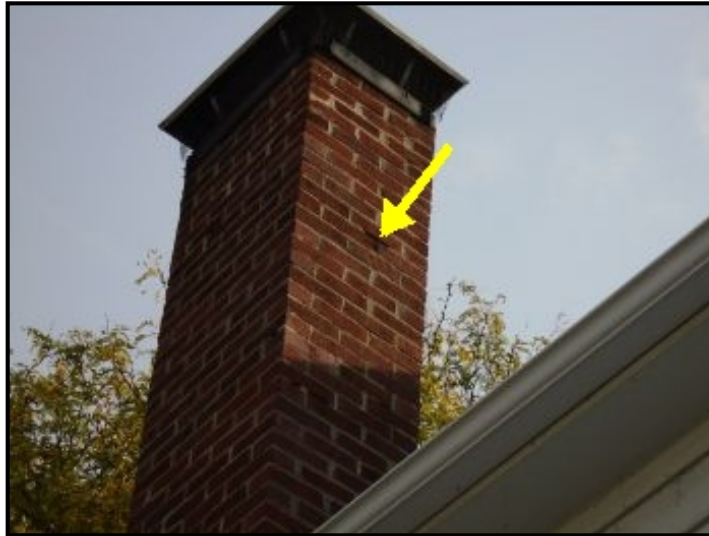
Some mortar deterioration observed at brick chimney requires tuck-pointing (2).
