CAI Home Inspection

Property Inspection Report

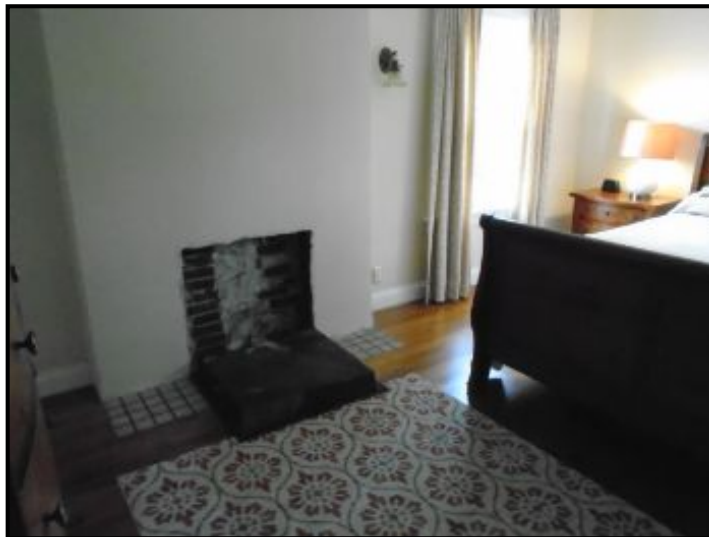
Upstairs fire place is not operable (2).
